Minerals Inspection Report

Mine Name: Black Butte	Permit Number: S/015/0080	Mine Status: Active
Operator Name: Goldterra Inc.	Inspection Date: 12/08/2014	Permit Fees: Paid
Inspector(s): Wayne Western	Inspection Time: 12:01 - 12:40 pm	Bond Amount: \$7,600
Attendee(s):	Weather: mild and clear	Bond Escalation: 03/26/2014
Inspection Purpose: Routine inspection		Prior Inspection: 10/30/2014

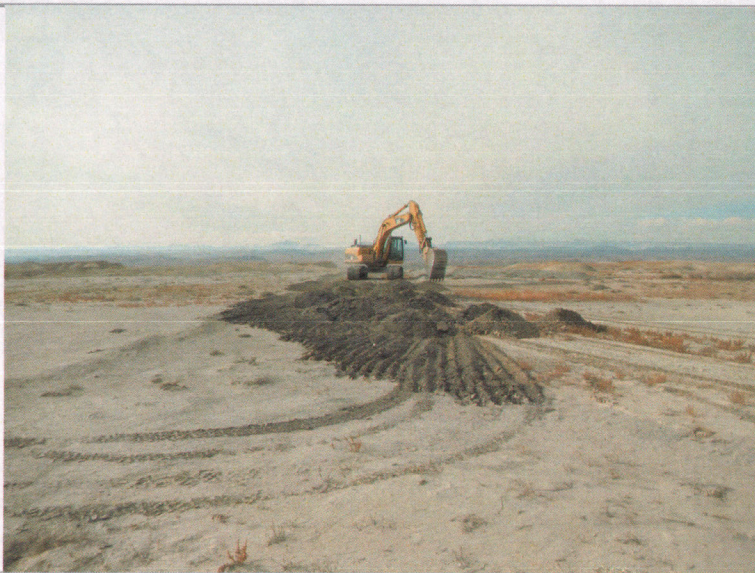
Looking west. Contractor is pocking the access road.

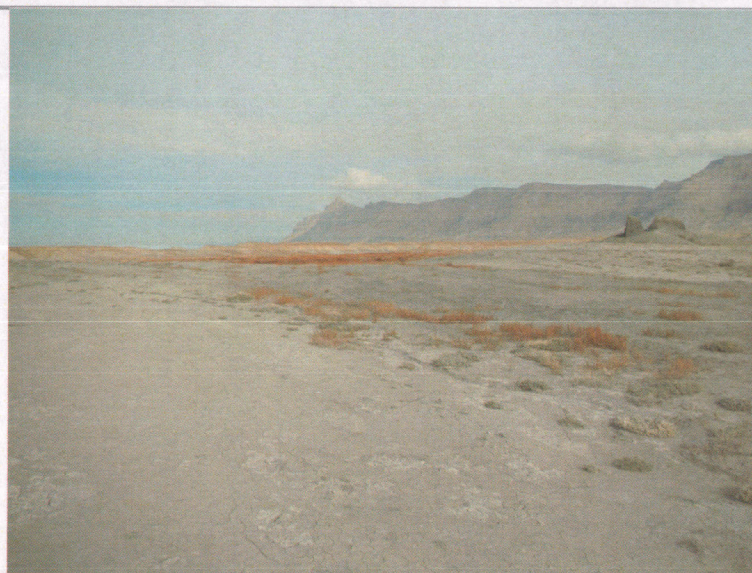
Rebar had been removed from the site.

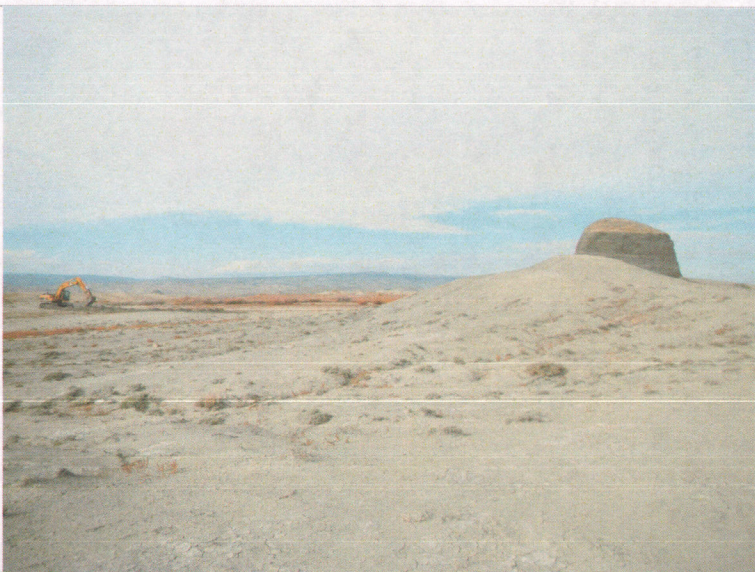
Looking west. Operator is pocking the access road. Note the mine area has been reclaimed some years ago.

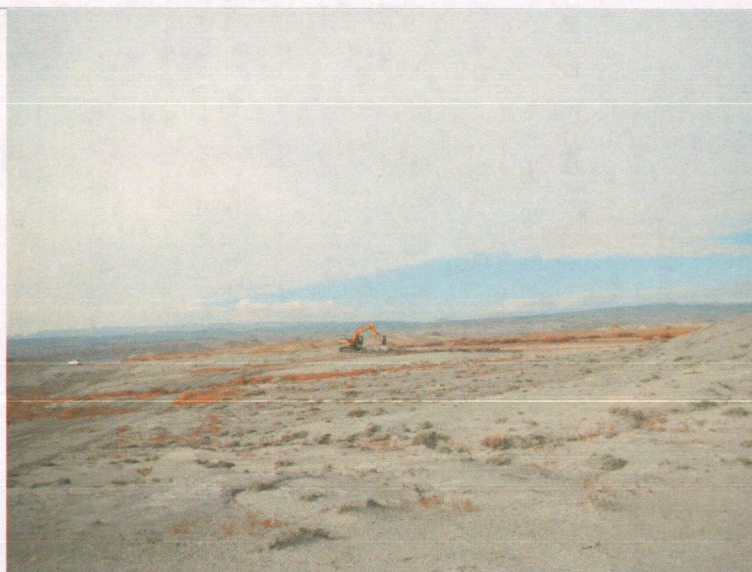
White truck in the left show were the pocking will stop. The road will to the check dam will be left in place.
